USAAMRDL TECHNICAL REPORT 72-31

AIRCRAFT CLUTCH ASSEMBLIES, RAMP ROLLER

Jules G. Kish

July 1972

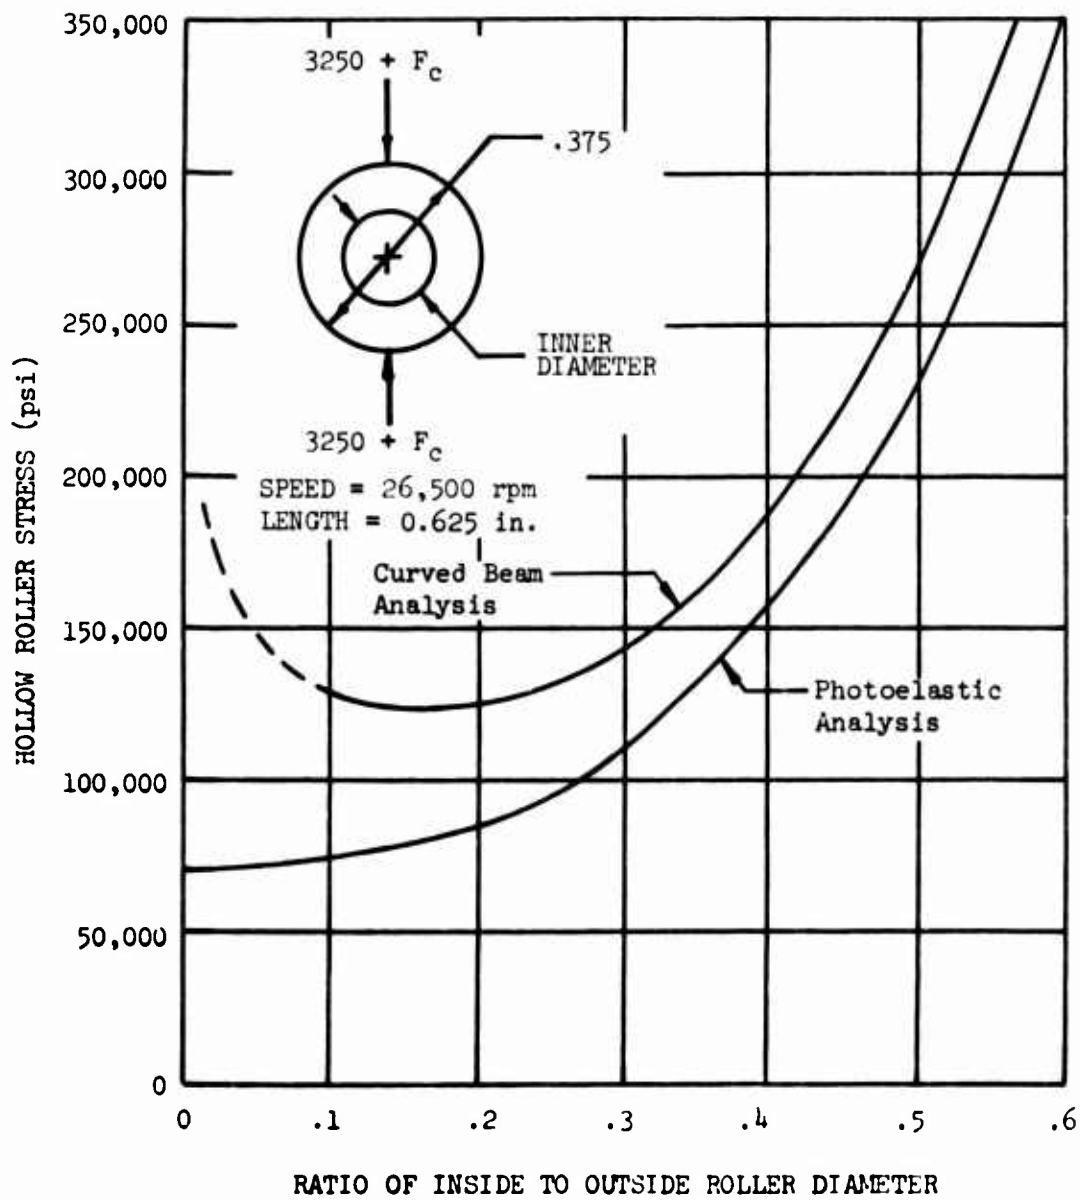
Figure 39. Hollow Roller Bending Stresses for 3570 In.-Lb Design Condition.

Although the rollers of the ramp roller clutch are designed statically, maximum stress dictates hollow roller design. The rollers are fabricated from CEVM 8620 steel and heat-treated to R_{59} minimum. This represents an ultimate tensile strength in excess of 300,000 psi. At the maximum operating condition, the allowable stress for hollow rollers can be in the order of 150,000 psi. This value is chosen on the basis of low cycle fatigue considerations. Referring to Figure 39, with an allowable stress of 150,000 psi, the ratio H is approximately .32 for the curved beam theory and .38 for the photoelastic analysis method; hence, a 0.125-inch-diameter hole ($H=.33$) is about the maximum practical diameter for use in the annular roller of the ramp roller clutch design presented herein.

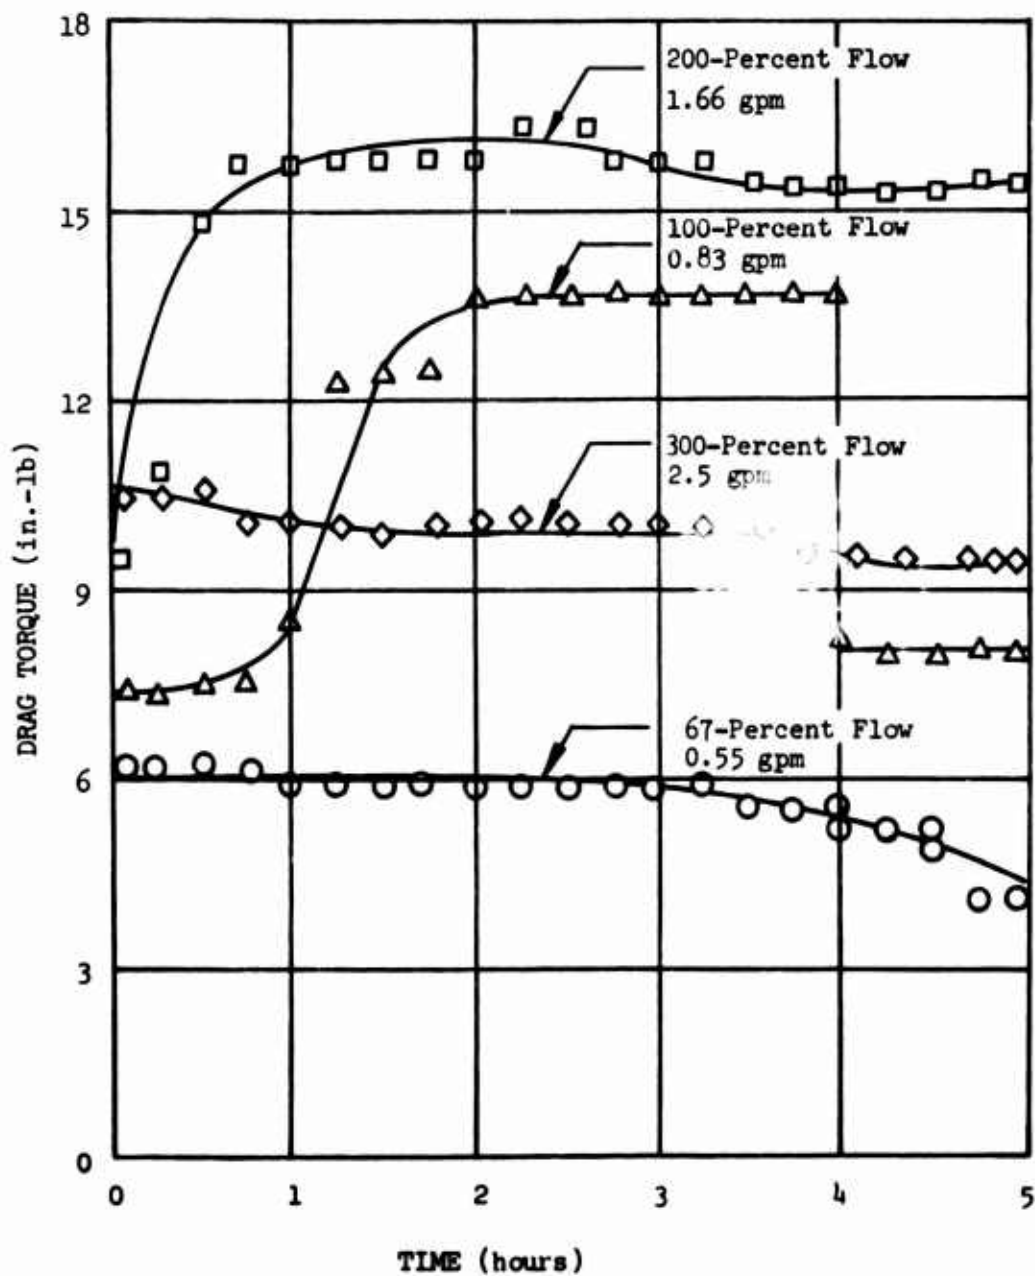
Figure 40. Full-Speed Overrunning Test Drag Torque Data Measured by Spring Scale and Arm.

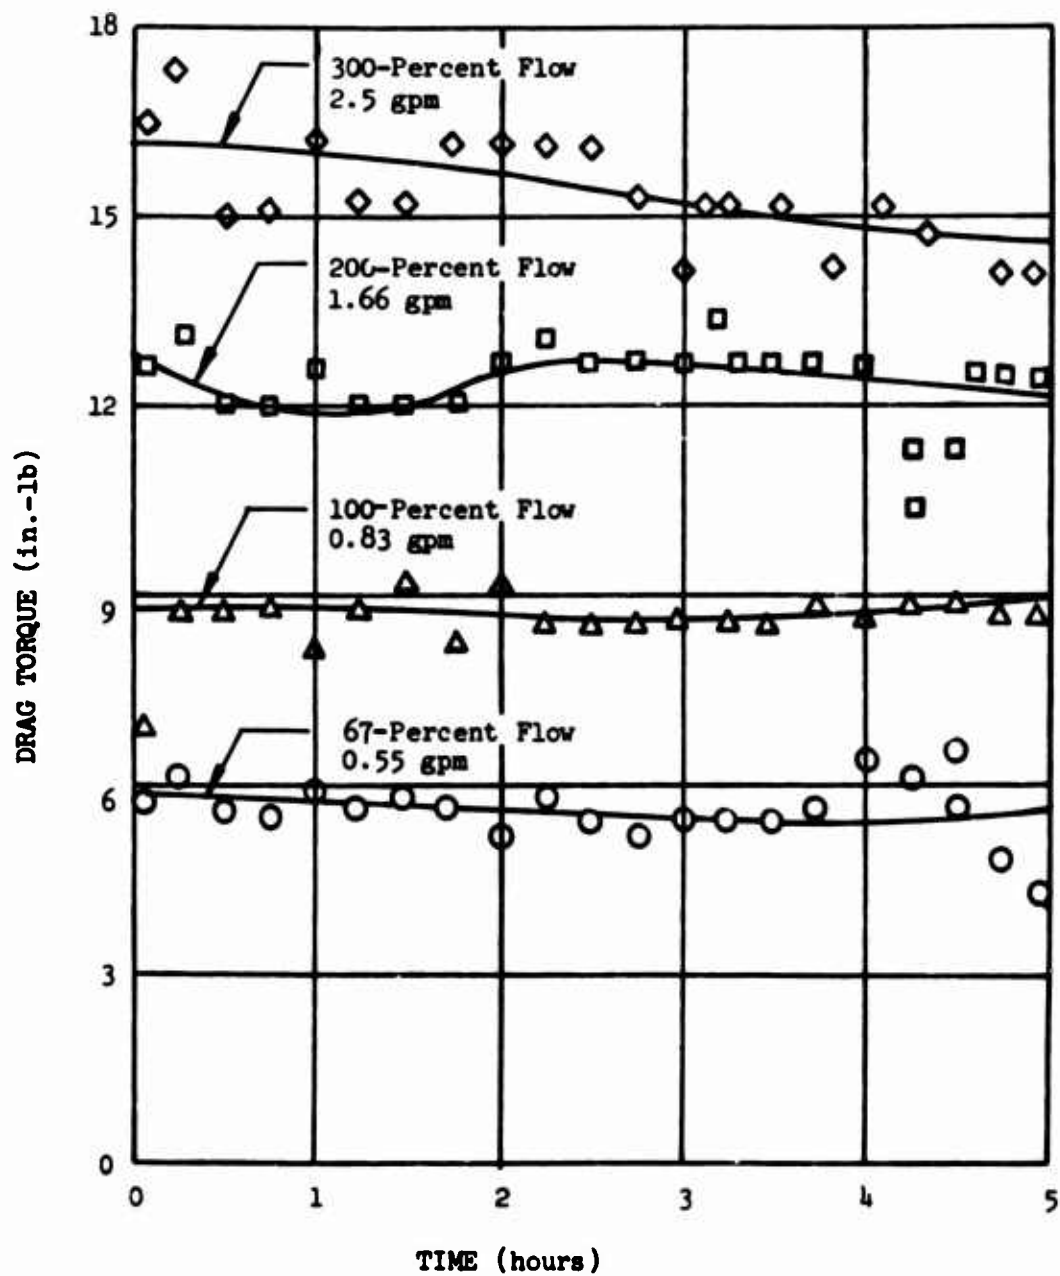
Figure 41. Full-Speed Overrunning (Input Stationary - Output 26,500 RPM)
Test Drag Torque Data Measured by Heat Absorbed in Oil.

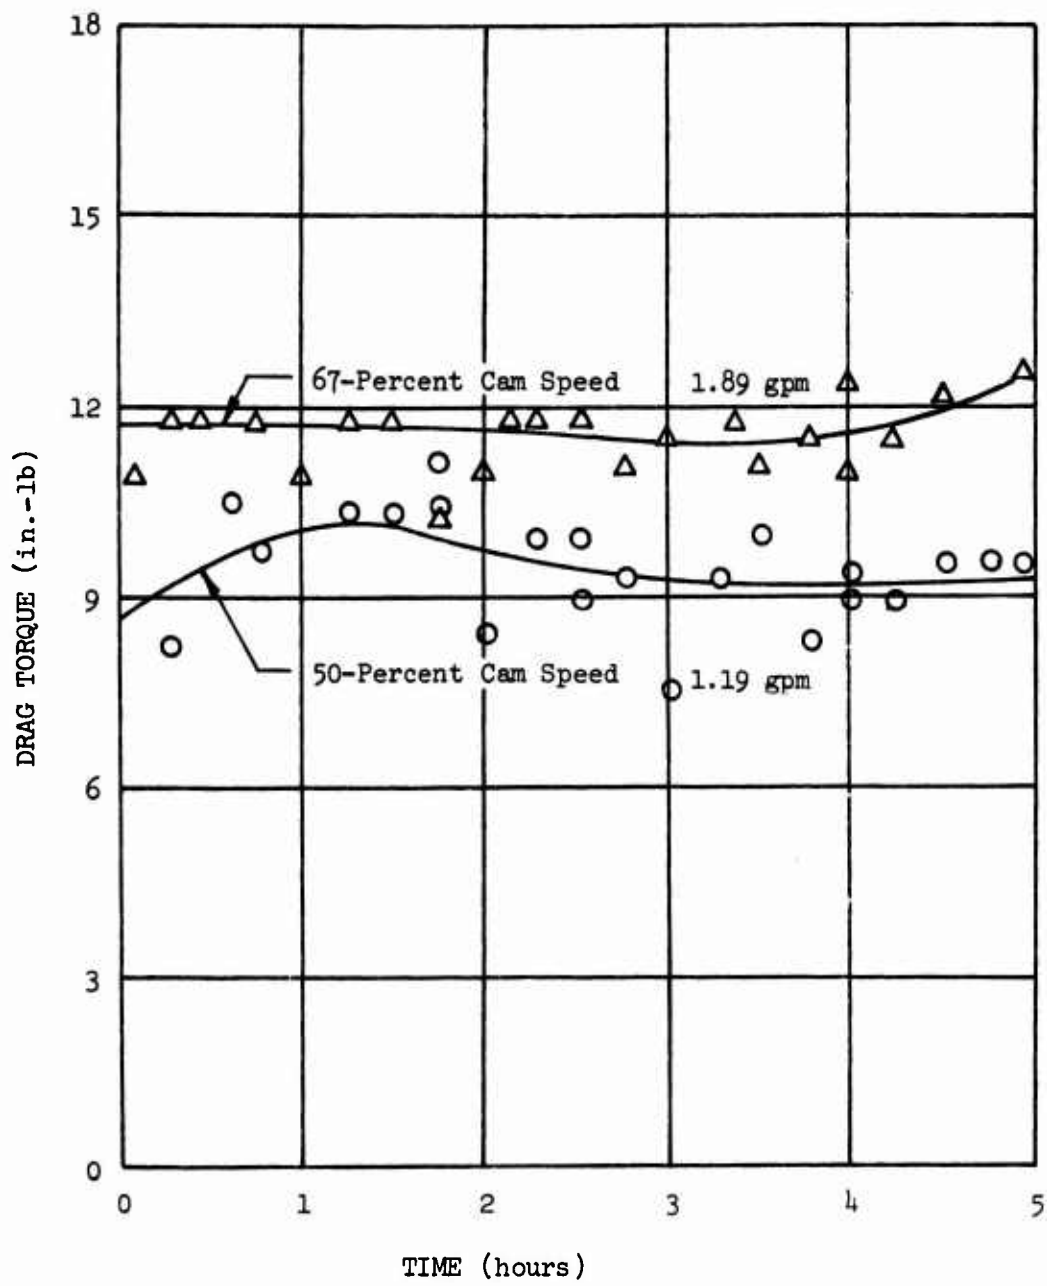
Figure 42. Differential-Speed Overrunning Test, Drag Torque Data.

Drag torque data for the differential speed overrunning tests is shown in Figure 42.
